Study on the Pollution Levels of Trace Metals from Modjo Tannery Effluent in the Surrounding River Water and Soil

Amanial Haile Reda. Study on the Pollution Levels of Trace Metals from Modjo Tannery Effluent in the Surrounding River Water and Soil. *Science Journal of Analytical Chemistry*. Vol. 3, No. 5, 2015, pp. 56-60. doi: 10.11648/j.sjac.20150305.13

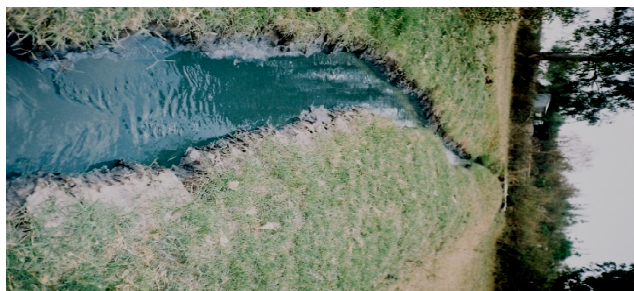
Figure 1. Drain (channel) where Modjo tannery wastewater travels from the source.

Tannery wastewater (effluent) samples were collected with 1 L-capacity polyethylene bottles at different distance along the wastewater channel. River water samples from which the tannery wastewater discharged to it were also collected from downstream site of the river at different distance. In a similar way another river water sample was also collected from the upstream site of the river to obtain a background or control sample and is believed free of the Modjo tannery wastewater. All river water samples were collected from the main flow of the stream at 3-5 cm depth. After collection 500 mL of each of wastewater and water samples were acidified to $\text{pH} < 2$ with concentrated nitric acid for metal analysis to prevent the precipitation of metals and finally stored in icebox and transported in to the Hawassa University chemistry department laboratory.
